Replacement Parts Bulletin

For Line Backer™ Circuit Switchers

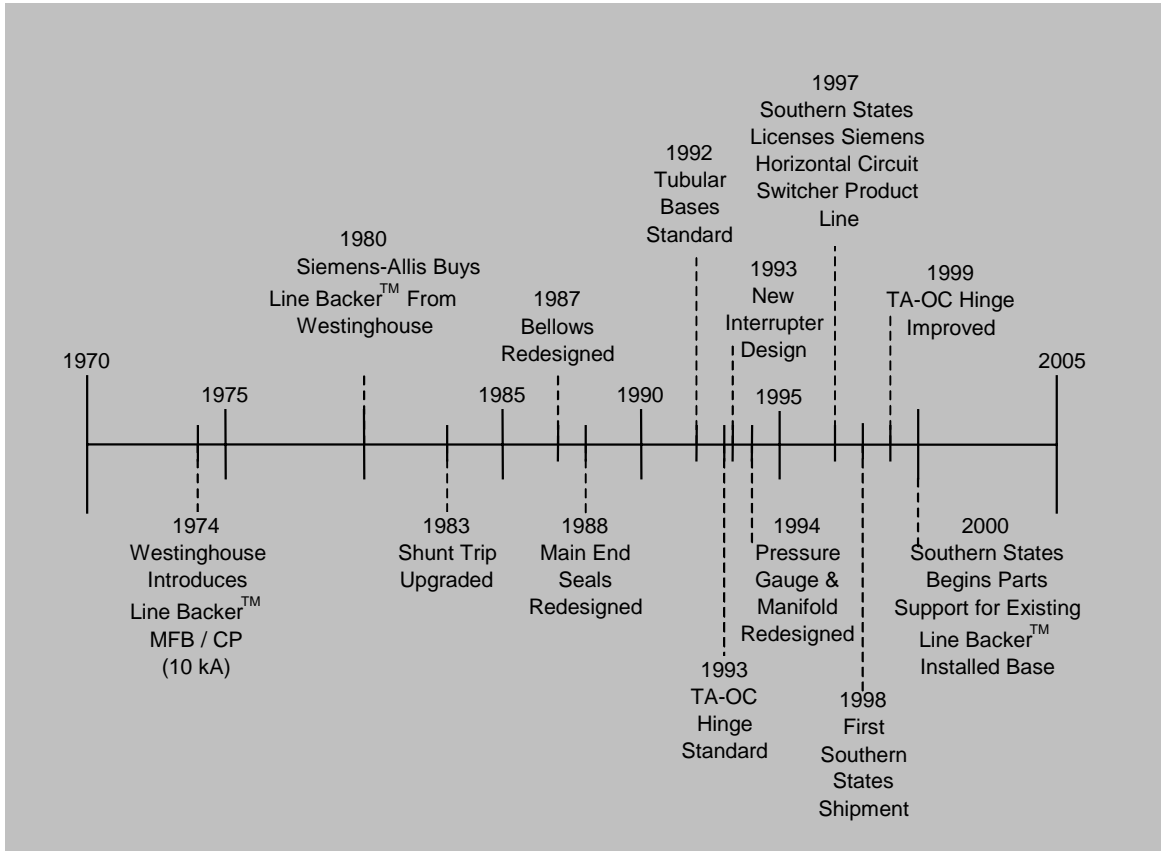
Figure 1 – Horizontal Circuit Switcher Timeline

Manufacturer	TYPE	
	Horizontal Non-Blade	Horizontal w/ Blade
Westinghouse	CP	MFB
Siemens-Allis	CP	MFB
Siemens	CP, CPS	MFB, CPS-VB
Southern States	CSH	CSH-B

Westinghouse introduced the MFB and CP Line Backer™ line of circuit switchers to the market in 1974. In 1980, Siemens-Allis purchased the Line Backer™ product line from Westinghouse, continuing to offer the MFB and CP. They later introduced the CPS and CPS-VB circuit switchers with higher interrupting ratings. Product quality problems drove Siemens to make major design changes, which resulted in a totally re-engineered product by the mid-90's.

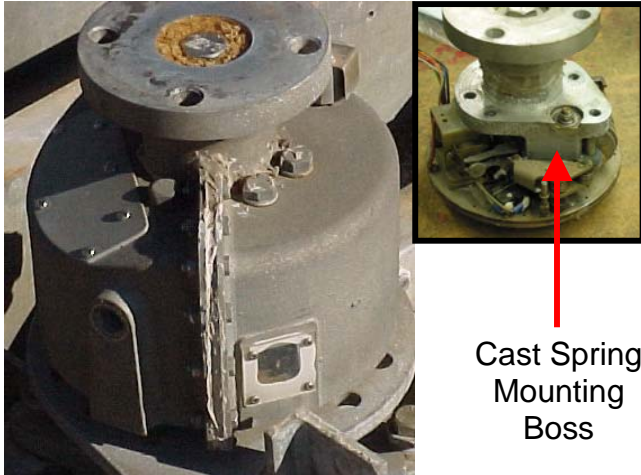
Figure 2 – Pre-November 1983 Shunt Trip Design

- Over time the seals for the two-piece casting (Figure 2) allowed moisture to enter the shunt trip resulting in component corrosion and electrical shorts. This led to nuisance operations or the disabling of the desired high speed tripping capability of the interrupter.
- The pre-November 1983 shunt trip design utilized a cast spring mounting boss (Figure 2). Multiple operations and corrosion caused by exposure to moisture can cause a fatigue crack in the boss that propagates throughout the casting, disabling the shunt trip.

- Replace your existing shunt trip with the current design (see Figure 3) that is a bolt-for-bolt replacement.

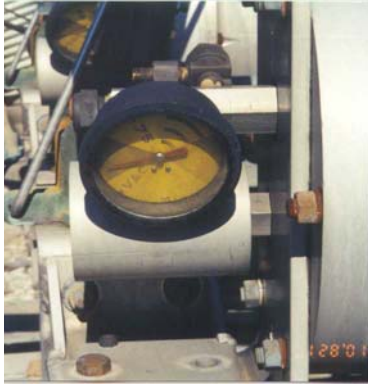
Figure 4 – Old style gauges and manifold

- Leaking from the bellows, flat gasket seals, gauge, rupture disk, or the epoxy that seals the manifold and its components to each other and to the interrupter may cause insufficient SF₆ gas pressure, resulting in the inability to clear system faults.
- Mechanical failure can occur inside the interrupter disabling its fault protection capability.
- The UV rays of the sun cause fading of the old style pressure gauge face making it impossible to verify the SF₆ level inside the interrupter (see Figure 4).

The best way to determine what interrupter is on your circuit switcher is from the data on the nameplate of each circuit switcher base. A visual inspection of the pressure gauge can also identify your interrupter. Interrupters with a black pressure gauge (see Figure 4) are the oldest and have the most problems. Interrupters with the newest gauge (see Figure 5) have all of the design improvements.

Upgrade your interrupter/driver with a bolt-for-bolt replacement that increases the performance and reliability of your circuit switcher.

- As a bolt-for-bolt replacement, the new interrupter/driver will have the same pad height and physical length as the existing unit allowing you to increase your fault interrupting capability without replacing the entire circuit switcher.
- The internal parts of the interrupter have been fully upgraded, increasing mechanical performance and reliability.
- Flat gaskets have been replaced by compression o-rings as the main end seals.
- The new gauge and manifold uses compression o-rings instead of epoxy to provide a significantly better gas seal.

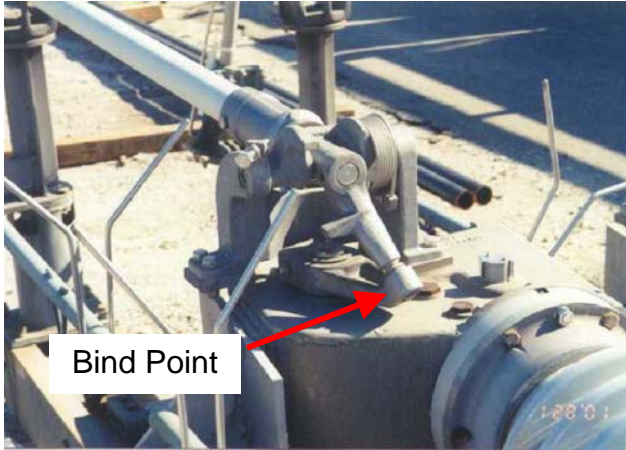
Figure 6 – “Dog leg” style hinge

- A geometric dead spot exists in the “dog leg” style hinge (see Figure 6). If the blade stops in the dead spot or seizes in any position, one or more hinge components may fail. The potential for failure is magnified because the aluminum pivot is vulnerable to oxidation which causes the hinge to seize, resulting in a component failure.

All MFB, CP, CPS, and CPS-VB units manufactured before January 1993 have a “dog leg” style hinge. All units manufactured after January 1993 have a TA-OC style hinge (see Figure 7).

- If your blade jumps or bounces as it closes then a problem definitely exists.
- All “dog leg” style hinges on circuit switchers have a geometric dead spot so an upgrade is advisable.

Upgrade to a TA-OC style hinge that has 30+ years of demonstrated reliable performance in the field. Since 1999, the TA-OC style hinge’s cross sectional area has been increased for improved performance under iced conditions. Due to the differences in hinge configuration an upgrade must also include a new blade, as the “dog leg” style hinge’s blade is too short to work with the TA-OC style hinge.

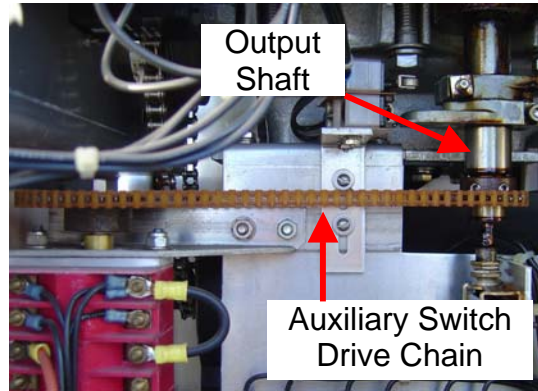
Figure 8 – Shows the output shaft and the nylon auxiliary switch drive chain for the auxiliary contacts

- If you have a three-door CM-4, CM-4A, or CM-4AL motor operator then under normal operating conditions grease can seep down the output shaft and into the reversing contactor, potentially causing an uncommanded operation of the circuit switcher. Two-door motor operators do not have this problem because their reversing contactor is located in a different location.
- The nylon auxiliary chain furnished in older CM-4, CM-4A, and CM-4AL motor operators will degrade and break, preventing the auxiliary contacts from changing state and making it impossible to determine, from a remote location, if the circuit switcher is closed or open.

- Check to see if you have a nylon auxiliary switch drive chain. If so, inspect your auxiliary switch drive chain to determine if it is brittle or has any “stripped” bushings.
- Next inspect for the presence of liquefied grease on the motor operator drive shaft.

- If you have a nylon drive chain an immediate replacement with our stainless steel drive chain is strongly recommended regardless of condition.
- Replacement of your motor operator with the CM-4AE motor operator is recommended if you are experiencing grease leakage.

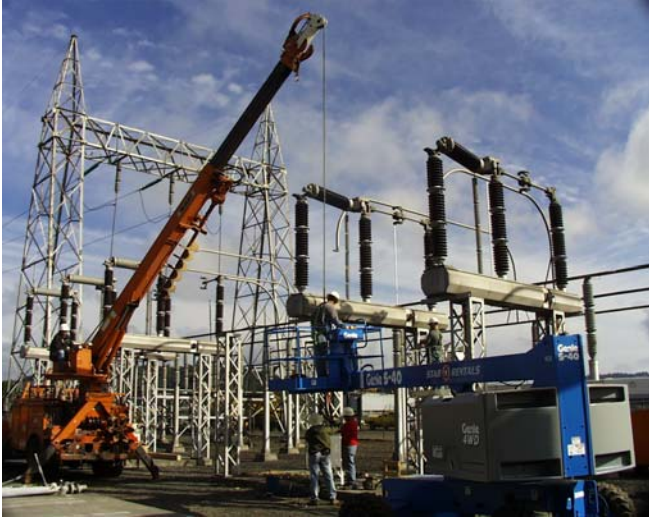
Figure 9 – Shows a competitor’s circuit switcher being removed from its support structure.

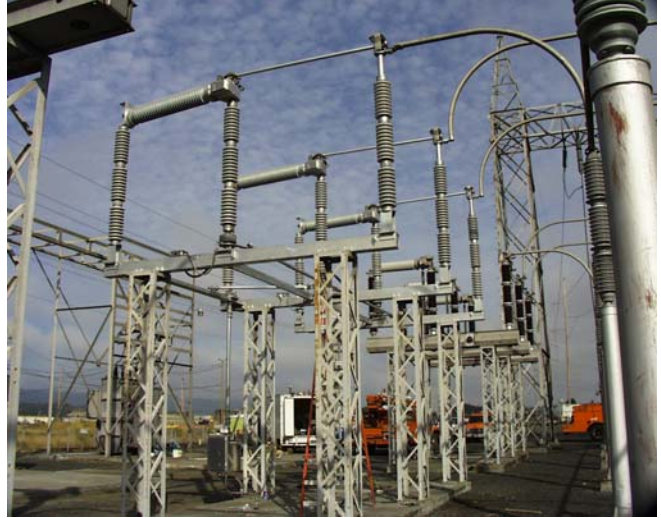
Figure 10 – Shows the Southern States CSH-B circuit switcher that replaced the competitor’s unit and reused the existing structure and foundations

Southern States can upgrade any installation’s fault interrupting capability to a full 20 kA by custom engineering our type CSH and CSH-B horizontal circuit switchers to adapt to virtually any support structure and phase spacing regardless of original manufacturer. Reusing the existing support structure and foundations will save on the first cost and total installed cost of your circuit switcher upgrade by reducing outage time and installation time.

If you have existing type MFB, CP, CPS, or CPS-VB Line Backers™ Southern States can replace your entire circuit switcher with a CSH or CSH-B that will have physical dimensions identical to your existing unit for a true bolt-for-bolt replacement. There will be no required reworking of the bus or relocating of conductors.
